National Grid Transco

Investigation Report into the Loss of Supply Incident affecting parts of South London at 18:20 on Thursday, 28 August 2003

Investigation Report into the Loss of Supply Incident affecting parts of South London at 18:20 on Thursday, 28 August 2003.

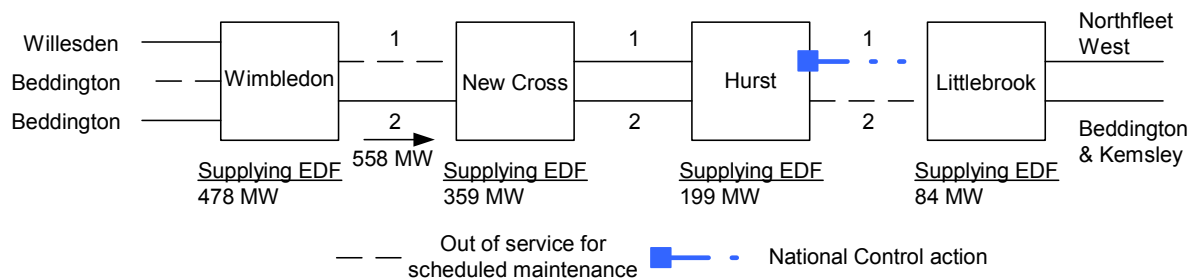
Figure 6: Transmission system at 18.20

- 61 At 18:20 two circuit breakers were opened at Hurst to remove the transformer or shunt reactor from service. At this point, the Hurst and New Cross substations were supplied from Wimbledon 275kV substation and were dependent on the single, number two circuit, from Wimbledon to New Cross.

- 62 Immediately following the opening of the two circuit breakers at Hurst, the automatic protection relay operated on the number two circuit from Wimbledon to New Cross automatically opening two circuit breakers at Wimbledon and removing the number two circuit from Wimbledon to New Cross from service. This isolated New Cross, Hurst and part of Wimbledon substations from the rest of the system. All supplies were lost at Hurst and New Cross substations and 35% of the supplies were also lost to EDF Energy's Wimbledon Grid 132kV substation. Two transformers at Wimbledon continued to supply Wimbledon Grid 132kV substation.
- 63 The transmission network was now configured as in the diagram below.

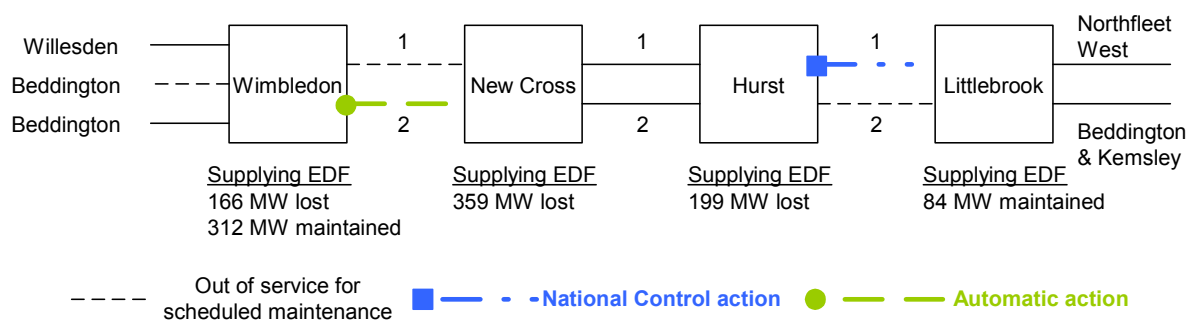
Figure 7: Transmission system immediately following the incident

- 65 Assessing the alarms received, National Control concluded that the automatic protection equipment on the number two circuit from Wimbledon to New Cross had most likely operated incorrectly.

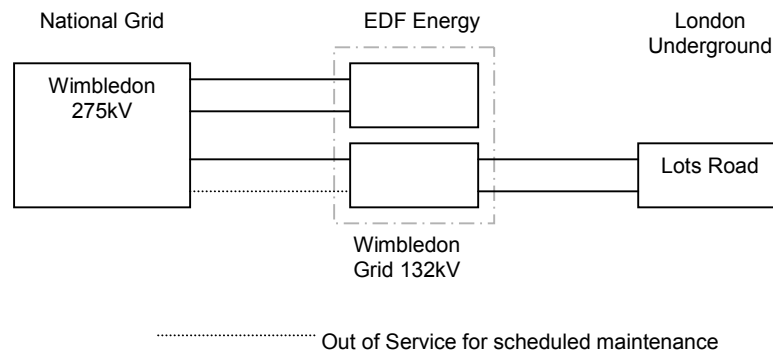
Figure 9: Configuration of EDF Energy's distribution system

- 124 The configuration of Wimbledon Grid 132kV substation on 28 August 2003 is illustrated in the diagram above. National Grid maintained supplies to the section connected to transformers two and four throughout the incident.

- 126 **The investigation found that the configuration of the EDF Energy's distribution system was not a contributory factor to the initiation of the incident. However, a more rapid implementation of post-fault actions or an alternative configuration could have mitigated the overall impact of the incident, reducing the duration and perhaps the scale of the loss of supply.**

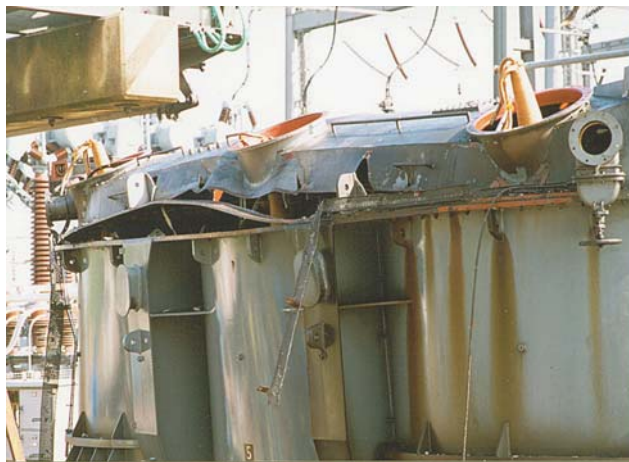
Figure 10: Failed Transformer

- 190 A Buchholz alarm is a dependable indication of an active fault within the transformer. The consequences of such a fault developing to failure are sufficiently severe to warrant disconnection. While the majority of transformers are removed from service before a major failure occurs, on occasions no warning is available. Approximately 20% of transformer failures result in a breach of the main tank. As shown below, the potential safety and environmental consequences of failure are clear.

- 191 In view of the potentially serious consequences of a transformer failure, it is National Grid's policy that National Control will immediately take transformers out of service when a Buchholz alarm is received. This policy takes into account the very low probability of a second circuit fault during the 5 to 10 minutes it would take to perform the switching operation, estimated to be less than 1:40,000. The exception to this is when the removal of the transformer would lead to a direct loss of supply, in which case the balance of risk favours a delay whilst further investigations take place.
